SOME METALLOGRAPHIC RESULTS FOR BRUSH BRISTLES AND BRUSH SEGMENTS
OF A SHROUD RING BRUSH SEAL TESTED IN A T-700 ENGINE

Robert C. Hendricks
NASA Lewis Research Center
Cleveland, Ohio

SUMMARY

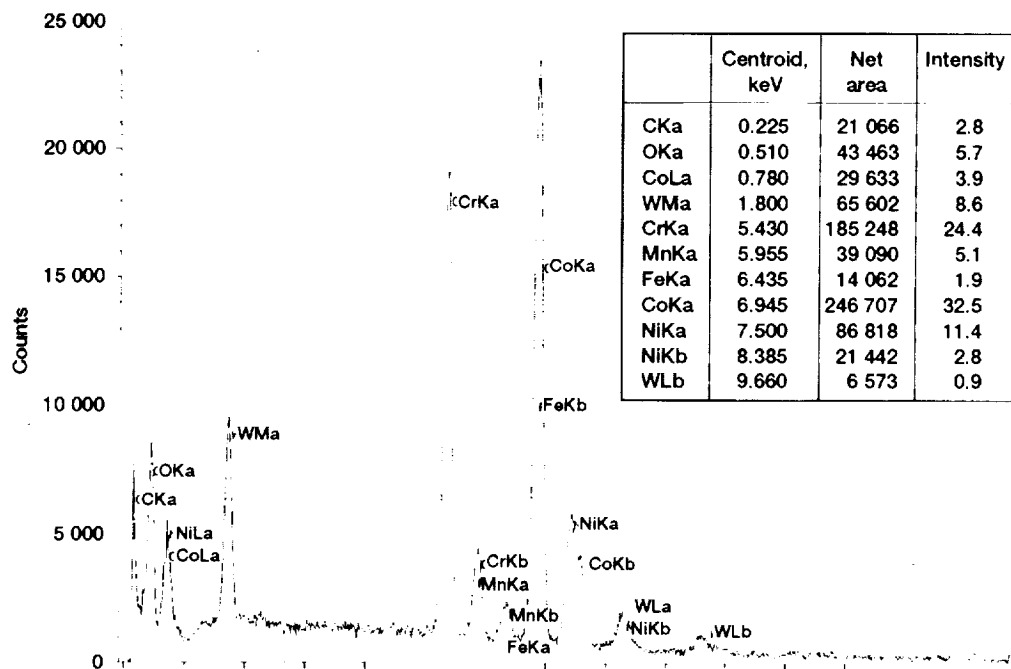
(a) Element distribution and tabulated results.

Figure 10.—Composition of bristle cut end. Beam current, 0.3 mA; count time, 200 s; accelerating potential, 20 kV; beam spot magnification, 2000.

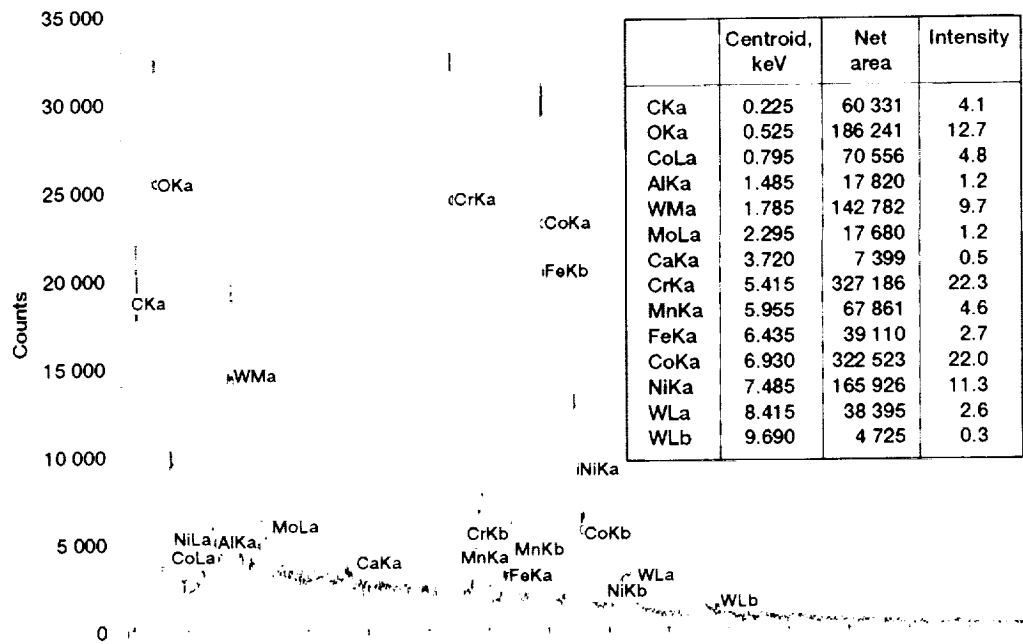
(a) Element distribution and tabulated results.

Figure 11.—Composition of bristle worm end. Beam current, 0.3 mA; count time, 200 s; accelerating potential, 20 kV; beam spot magnification, 5000.

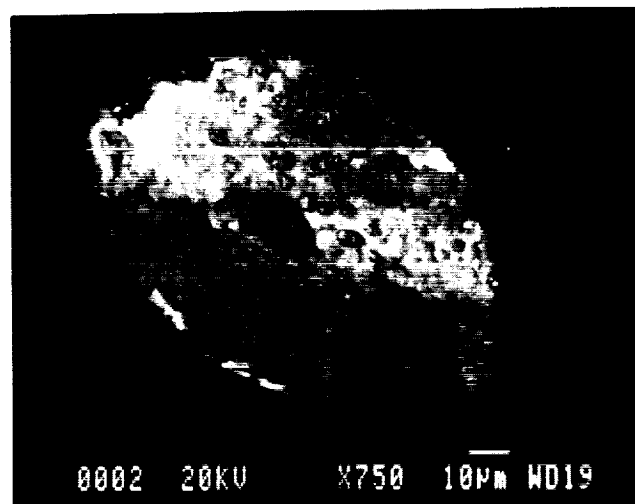
With significant material transfer to the rotor and oxide scale formation over the bristle surface, an examination of a bristle tip (fig. 14) showed wear traces, pitting, and material transfer. Figure 15 illustrates that although the base material appears as Haynes 25, the distribution of tungsten differs as noted in the element spectra. Therefore, some form of resolidification must have occurred right at the bristle-rub runner interface.

Figure 14.—Material transfer at bristle tip.

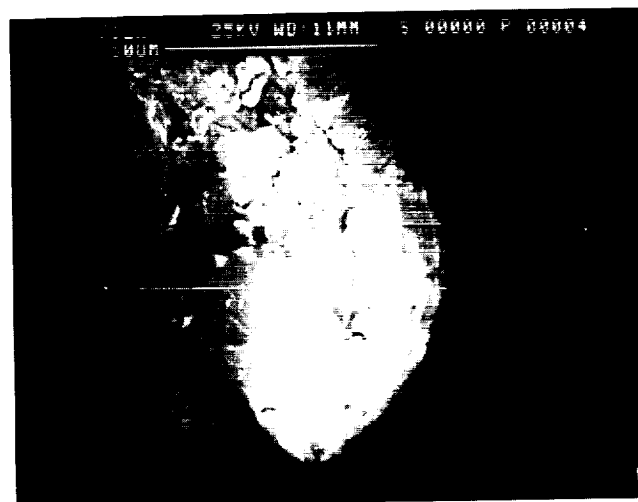
Some additional micrographs illustrated carbon spots on the bristle surfaces (fig. 16). Bristle tips and irregular bristles found in the exhaust duct of the T-700 engine are shown in figures 17 and 18. Oxide scaling is noted but also apparent is a form of resolidification. The events associated with bristle loss at engine startup are discussed in reference 1. In this regard the reader is reminded that the brush was installed and disassembled "blind" (ref. 1).

Figure 17.—Typical bristle tip collected in T-700 exhaust duct.

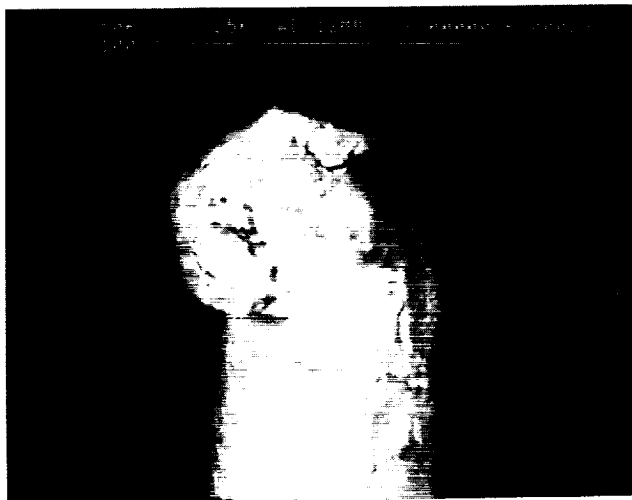
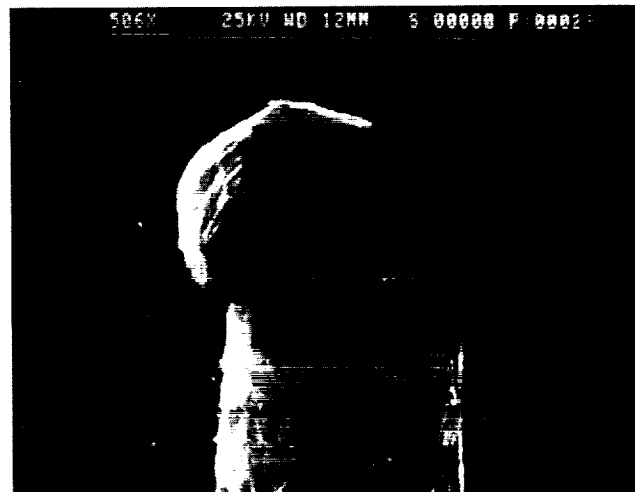
(a) Bristle tip 1 (two exposures).

Figure 18.—Typical bristle tip collected in T-700 exhaust duct, showing possible rubbed and quenched interface.
